Manhole Inspection Summary

Manhole # S29AA1029MH

Location Address: **709 36TH ST**

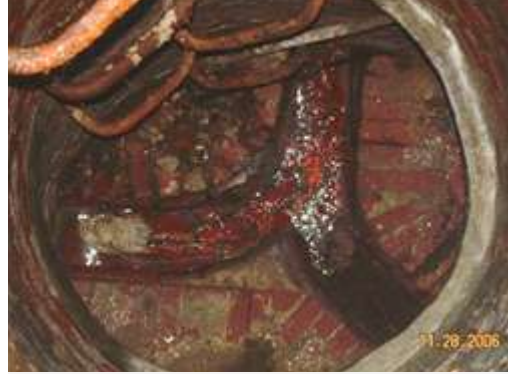
Top View

Corroded steps. Bench debris.

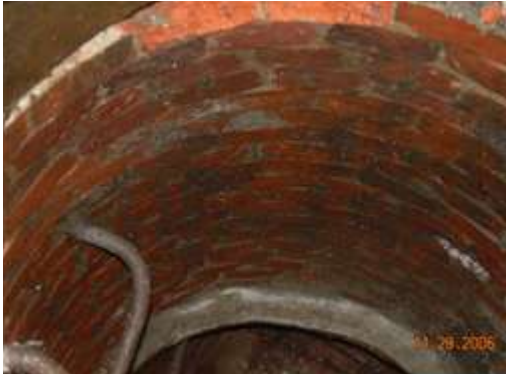
Defect

Frame leaks. Adjustment deterioration and infiltration. Corbel and Barrel infiltration

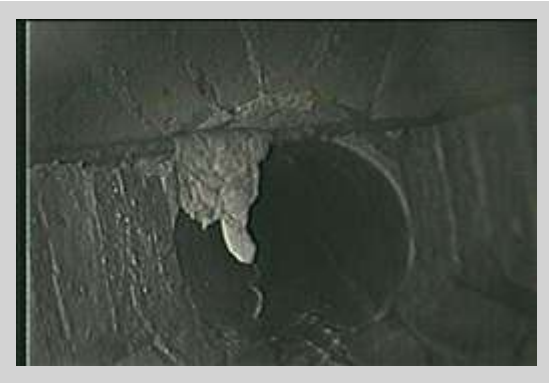
8 in. Circular Gravity Sewer Pipe Out @ 12 O'Clock

Infiltration: **Evidence** Pipe Seal Cond: **Cracked**

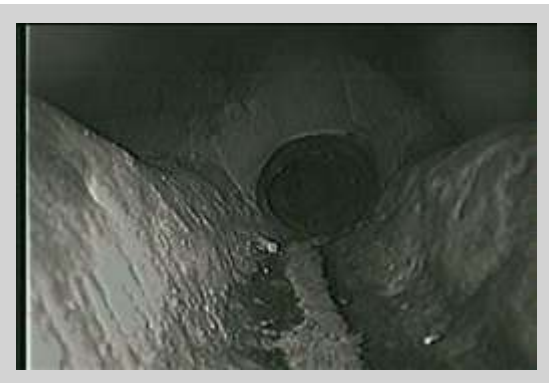
6 in. Circular Gravity Sewer Pipe In @ 4 O'Clock

Infiltration: **Evidence** Pipe Seal Cond: **Unknown**

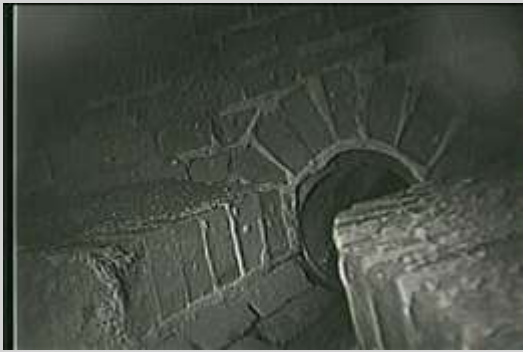
Pipe In @ 5 O'Clock

Infiltration: **Evidence** Pipe Seal Cond: **Unknown**
